# Field Study of Hygrothermal Performance of Cross-Laminated Timber Wall Assemblies with Built-in Moisture

Ruth McClung<sup>1</sup>, John Straube<sup>2</sup>, Hua Ge<sup>1</sup>, and Jieying Wang<sup>3</sup>

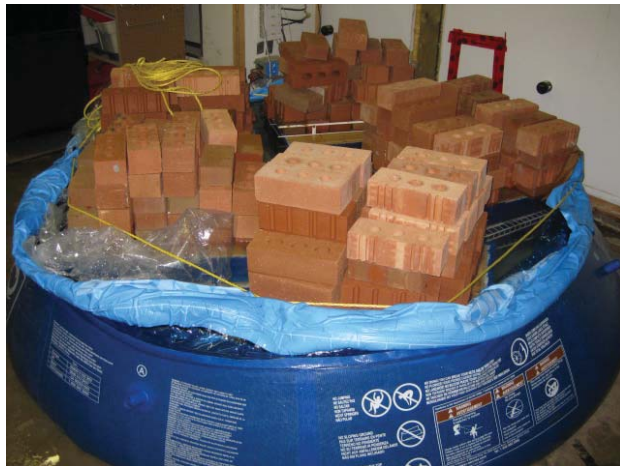
A large children's swimming pool was used for wetting. The panels were placed in the pool in five stacks, with spacers between the pool floor, and each of the panels. Bricks were then stacked on top of the panels to act as ballast as the pool was filled with water. Unfortunately, the advertised depth of the pool could not be obtained. The panels on the tops of the stacks were initially covered in water when wetting began, but the pool leaked water overnight until the water level stabilised about halfway up the top panel of each stack. As the pool was set up in the test facility, which has no plumbing, the amount of water available for wetting was limited. Consequently the top of some panels were left

Fig. 5. Soaking of CLT panels in pool

exposed to the air with only the bottom faces immersed. These panels were marked, and the dry faces were placed where their drying conditions were closely replicated elsewhere, usually as the interior freely drying face of the assemblies.

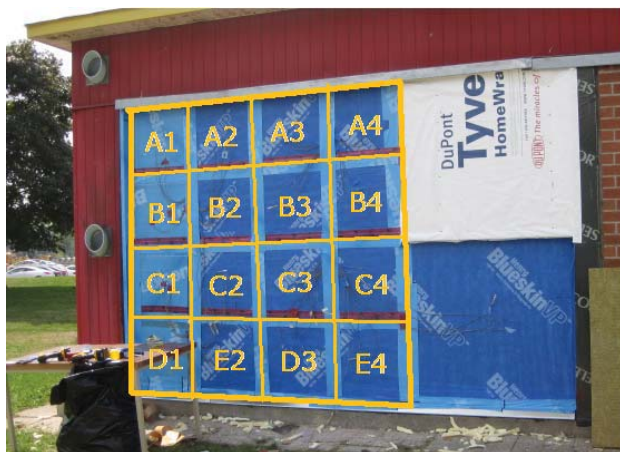
Figures 5 through 8 show several stages during the construction of the test wall. The large CLT panel and stud

Fig. 6. After installation of water resistive barriers

wall section above it are not discussed in this paper. The low exterior and low interior permeance panels had Blueskin and polyethylene sheeting, respectively, applied to them several hours after the wetting pool was drained. The insulation was installed approximately 30 hours after the wetting pool was drained, enclosing the panels in their final drying environments. 12 hours were required to attach all the sensors to the logging system, and data collection began on August 20, 2011, approximately 80 hours after the wetting pool was drained.

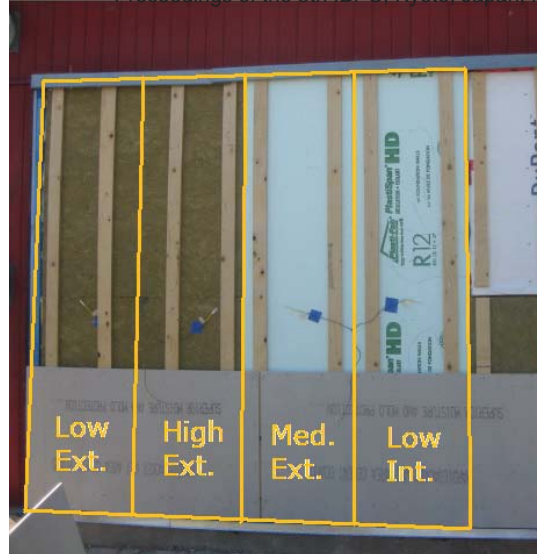
Fig. 7. CLT test wall with insulation, strapping and cladding.

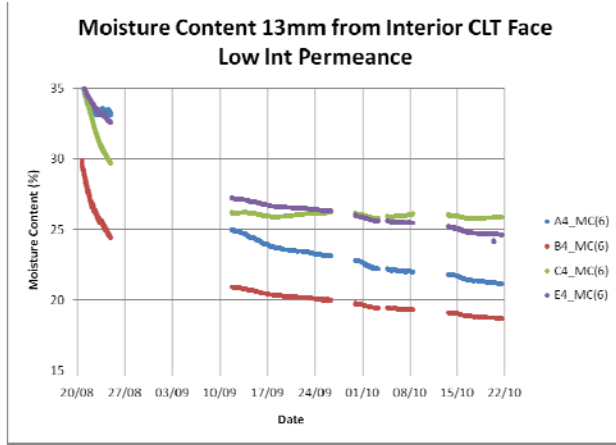
The panels with polyethylene sheeting on the interior face showed slightly less uniform behaviour, especially in the first few days of rapid drying, as seen in Figure 10. The European panel, A4, dried more quickly than the others initially, which may indicate that liquid moisture transport occurred more readily, redistributing into the centre of the European panels when drying to the free surface was dramatically slowed. The rate in decline of MC for panel C4, the Western SPF panel, is extremely low compared to the other three panels after the initial drying phase.

Fig. 10. Moisture Content 13mm from Interior CLT Face for Low Interior Permeance Panels

The MC in all the low interior permeance panels remained at a very high level, with only two panel dropping significantly below 26% after two months. While it was expected that the low interior permeance panels be the worst performing hygrothermally, with the highest risk of damage due to moisture, this measured data confirms that the moisture content does not redistribute quickly enough to the centre of the panels, sufficiently lowering the MC in the outer layers in a fast enough time frame to safely prevent mould and rot.

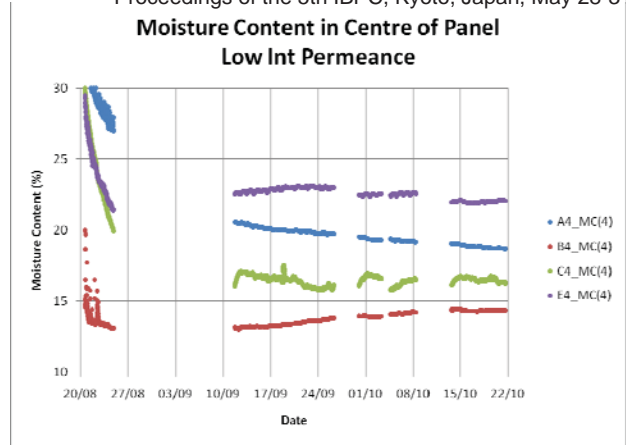
The MC 19 mm into the interior face are slightly higher than at the 13 mm mark, but the drying patterns are the same, as seen in Figure 11. This trend of higher moisture contents deeper into the face of the panel is mirrored across the entire test wall. The MC in the centre of the panel, in Figure 12, is lower than at the interior face, allowing moisture to redistribute into the centre, and the rate of drying into the centre is much lower than at the face, and in some cases the MC in the centre rises. This indicates that the moisture at the interior face of the panels with polyethylene is drying into the centre of the panel, and the moisture in the centre of the panel is drying further to the exterior CLT face.

Fig. 12. Moisture Content in Centre of Panel for Low Interior Permeance Panels

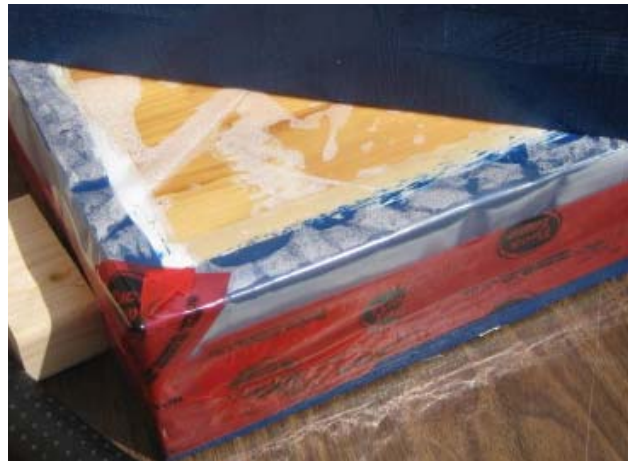
An additional point of concern for wood durability is the possibility of mould growth on the surface at a relative humidity above 80%. For the panels with low permeance materials adjacent to them, the RH sensors were not placed directly on the wood surface, they were placed between the non-vapour permeable membrane and the insulation for the exterior low permeance panels, and in the interior cavity for the low interior permeance panels. However, at the time of installation, extensive condensation was present on the inside of the polyethylene sheet on the low interior permeance panels, in Figure 13. Given the slow rate of drying, it is likely that the RH on the surface of the panel remains well above 80%, even after two months. The same is likely the case for the panels with low exterior permeance, though the opaque vapour barrier masks condensation.

Fig. 13. Condensation on Interior of Polyethylene Sheet for Low Interior Permeance Panels

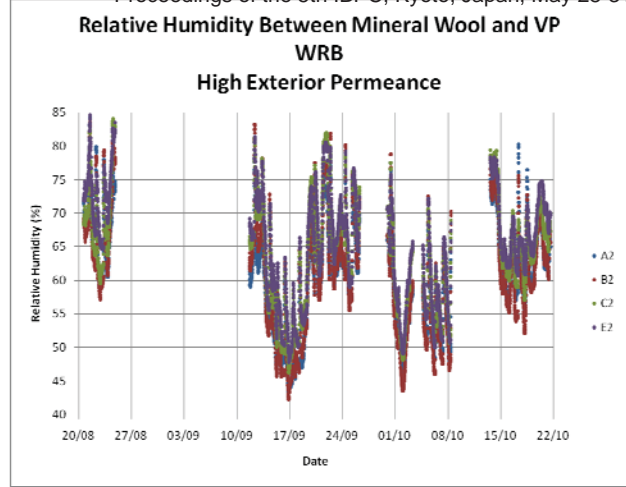
The risk of mould growth for the high exterior permeance panels is low, as the highly vapour permeable mineral wool means the RH adjacent to the panel surface closely mirrors the ambient RH, rising above 80% only occasionally, for brief periods, as shown in Figure 15.

Fig. 15. Relative Humidity Between Mineral Wool and VP WRB for High Exterior Permeance Panels

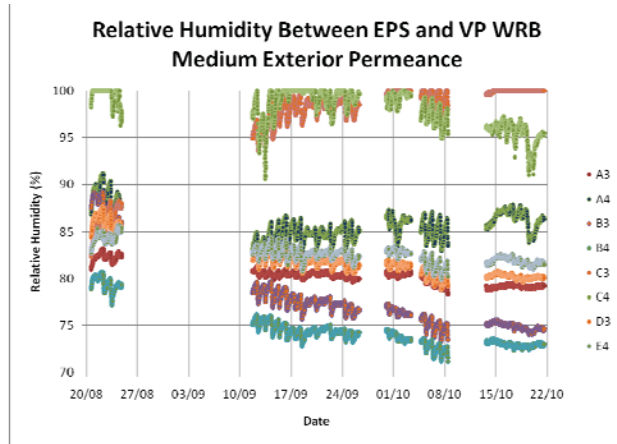
Although the MC in the panels with medium exterior permeance may be low enough to prevent wood decay, the relative humidity on the exterior panel face remains above 80% for the majority of the panels, shown in Figure 17. The two panels with the highest RH levels are both made of Western SPF, which may indicate a different in behaviour between CLT panel wood species groups. Due to the medium vapour permeance of the EPS insulation, the relative humidity adjacent to the panel is very stable, which prevents the RH from decreasing during each day, when the ambient

RH is low, as occurs for the panels with high exterior vapour permeance. These sustained, elevated RH levels present a serious risk of mould growth.

Fig. 17. Relative Humidity Between EPS and VP WRB for Medium Exterior Permeance Panels

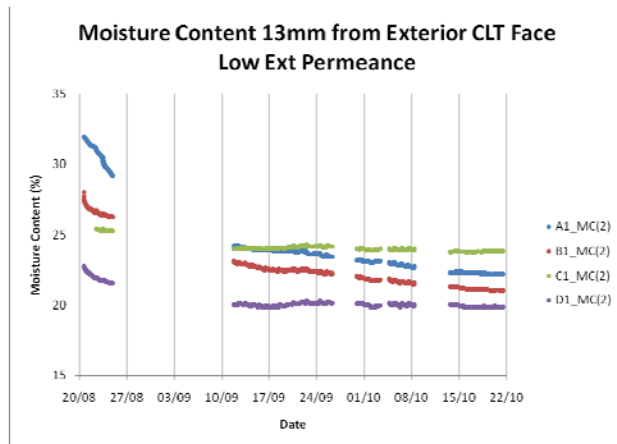
The panels with low exterior vapour permeance were again expected to perform very poorly. They appear to be reaching equilibrium between 20% and 25% MC, just below the danger zone for wood products. This again indicates that moisture redistribution into the centre of the panel may occur too slowly to safely prevent moisture related durability issues.

Fig. 18. Moisture Content 13mm from Exterior CLT Face for Low Exterior Permeance Panels

Figures 14, 16, and 18 show the moisture contents 13mm from the exterior faces of the high, medium, and low exterior permeance CLT panels, respectively.
